Our Ref: Chilt/IF13037

**Re: Indicative Fire Resistance to the temperature and pressure conditions of
BS 476: Part 20/22: 1987 (and current FTSG Resolutions where applicable).
Test Chilt/IF13037**

The overall size of the leaf was 1250mm high x 1230mm wide x 54mm thick. and included two Vistamatic VS1 secure vision panels.

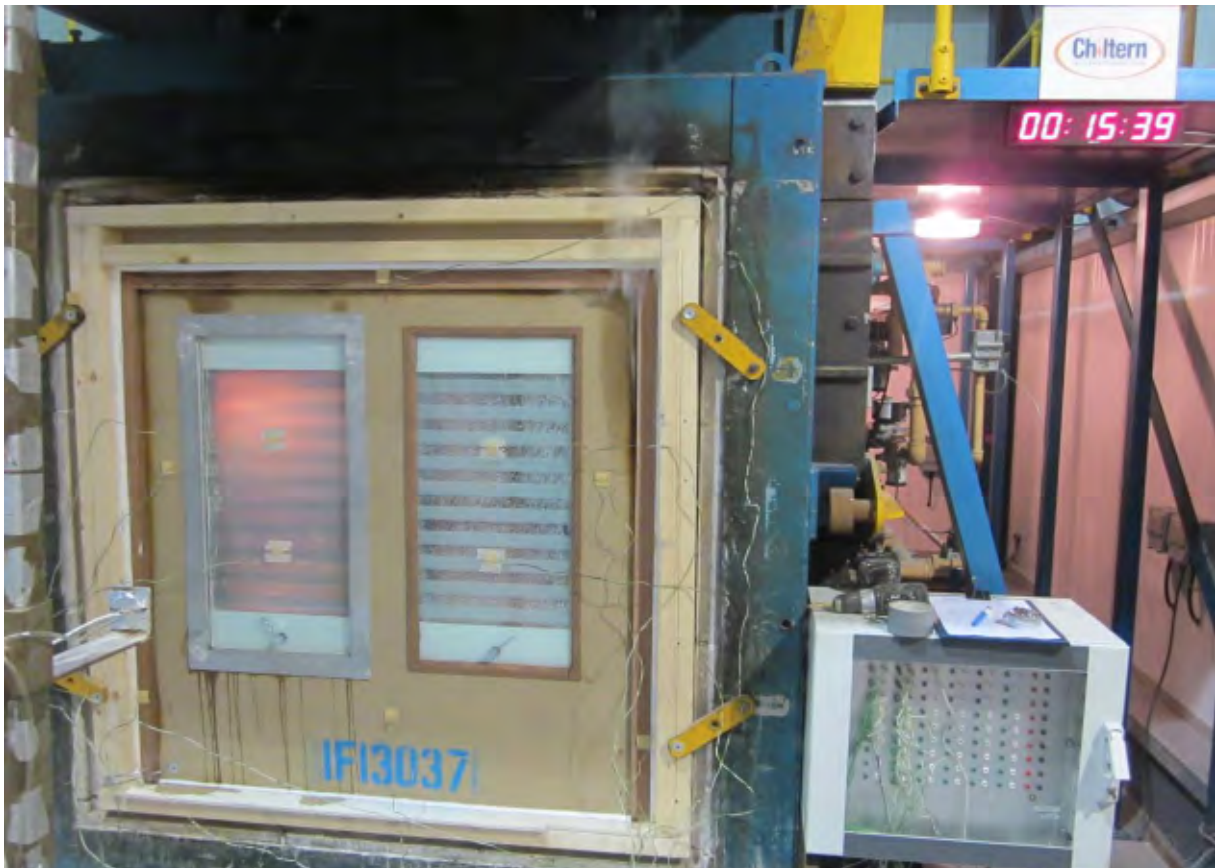
After 15 minutes

13.00	Glazing panel B, the exposed layer of glazing has shattered and the middle layer has cracked.
19.00	Glazing panel B, there are more cracks appearing in the middle layer of the glazing.

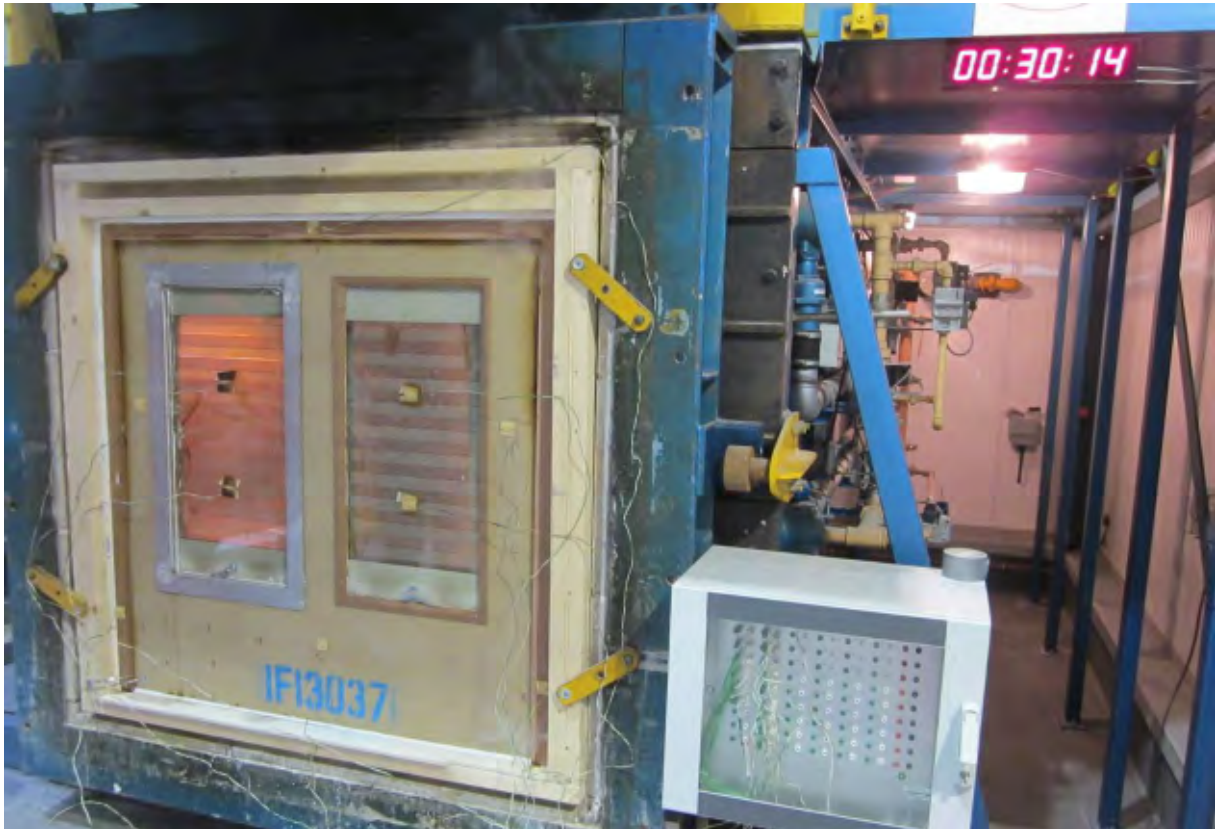
After 30 minutes

21.00	Glazing panel A, the middle glazing layer is cracking.
25.00	Glazing panel A, there is further cracking in the middle layer of the glazing.
27.00	Glazing panel A, a gap (approximately 1-2mm wide) has opened around the glazing bead.

28.10	Glazing panel A, there is an increase in the level of smoke issuing from the glazing perimeter.
29.00	Glazing panel B, the intumescent around the glazing is starting to react.

32.10	Glazing panel B, the unexposed glazing layer has cracked.
32.20	Glazing panel A, there is smoke issuing from around obscuring lever spindle of the glazing.

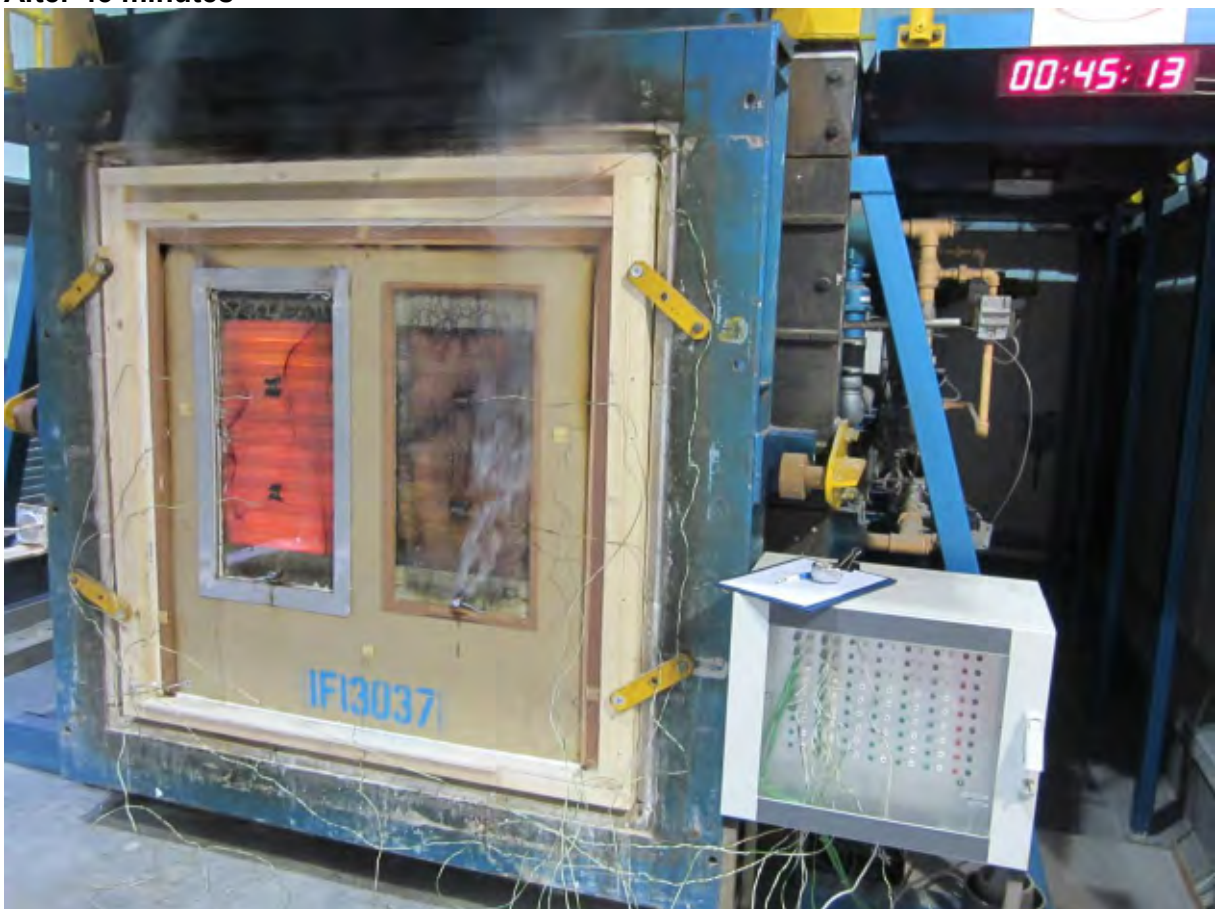
After 45 minutes

33.40	The obscuring levers on both glazing panels are falling out.
34.30	Glazing panel B, there is smoke issuing from across the face of the glazing.
36.00	Glazing panel A, there is discolouration of the leaf at the top left corner of the glazing panel.

37.30	Glazing panel A, the gap around the glazing bead and the leaf is now approximately 4-5mm wide.
38.00	Glazing panel B, there is an increase in the level of smoke issuing from the obscuring lever.

41.00	Glazing panel B, the exposed face glazing is still in place.
46.00	Glazing panel B, there is smoke issuing from the perimeter of the glazing.

- 47.30 Glazing panel B, there is discolouration of the top glazing bead.
- 51.00 Glazing panel A, there is discolouration of the leaf at the top right corner of the glazing.

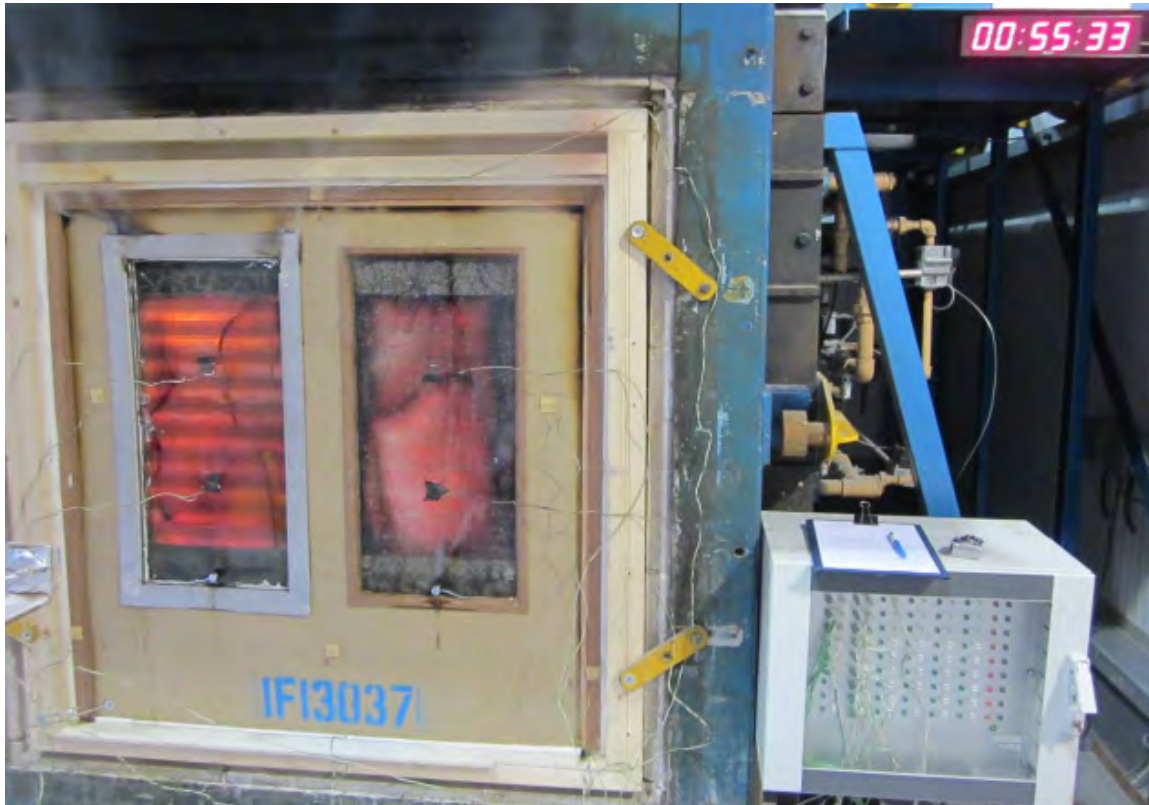
After 55 minutes

- 54.00 Glazing panel B, there is an increase in the level of smoke issuing from the glazing perimeter.
- 55.00 Glazing panel B, there is further cracking in the exposed glazing layer.

- 56.30 Glazing panel B, the exposed glazing layer is falling away.
- 57.30 Glazing panel B, the bottom half of the exposed glazing layer has fallen away.

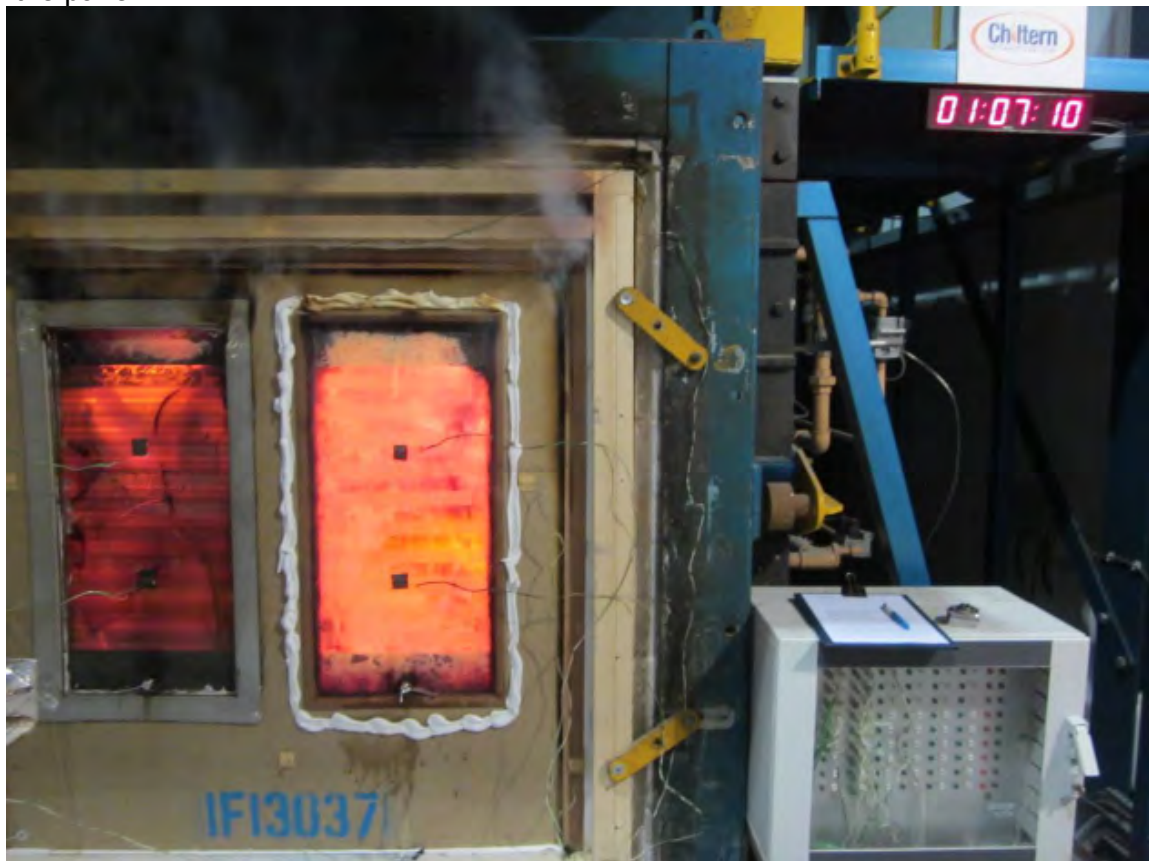
- 63.00 Glazing panel A, the exposed layer is starting to melt and fall out of the top.
- 65.45 Glazing panel B, there is flaming for in excess of ten seconds from around the obscuring spindle spreading to the beading of the glazing.

After 67 minutes – Mastic applied to perimeter of glazing panel B in preparation of blocking off the panel
