# Fire resistance test report

Test standard: EN 1634-1:2014+A1:2018

Product: Two Single Leaf, Single Acting Timber Doorset  
With Vision Panels

Report number: WF502390/Rev1

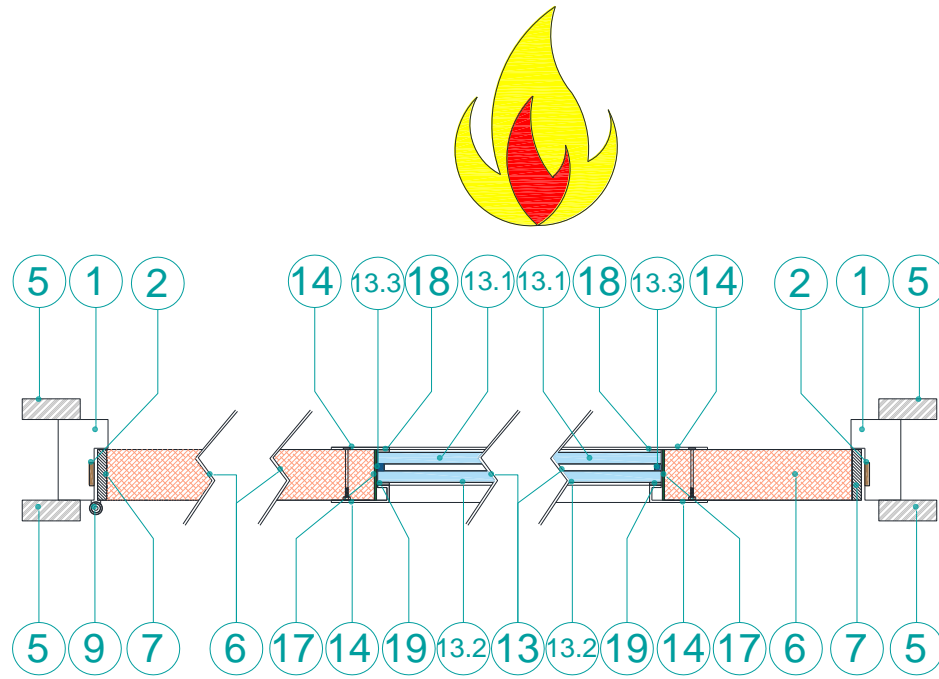
Figure 3 Horizontal Sectional View – Doorset A

Representative Drawing

The leaders in the drawings (Figure 1 - Figure 3) represent the items listed in section 2.2. All measurements are in millimetres – unless indicated otherwise.

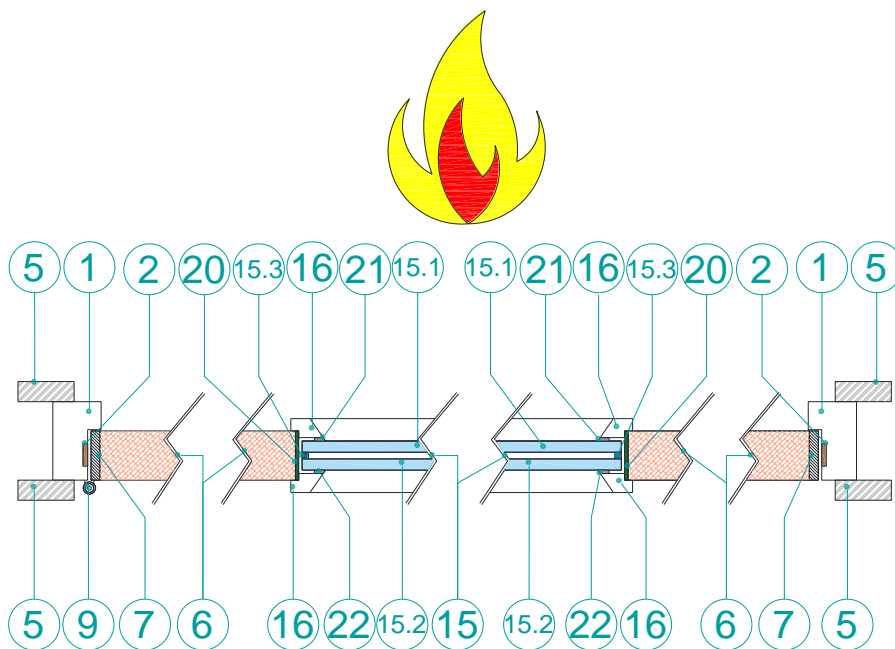
Figure 4 Horizontal Sectional View – Doorset B

Representative Drawing

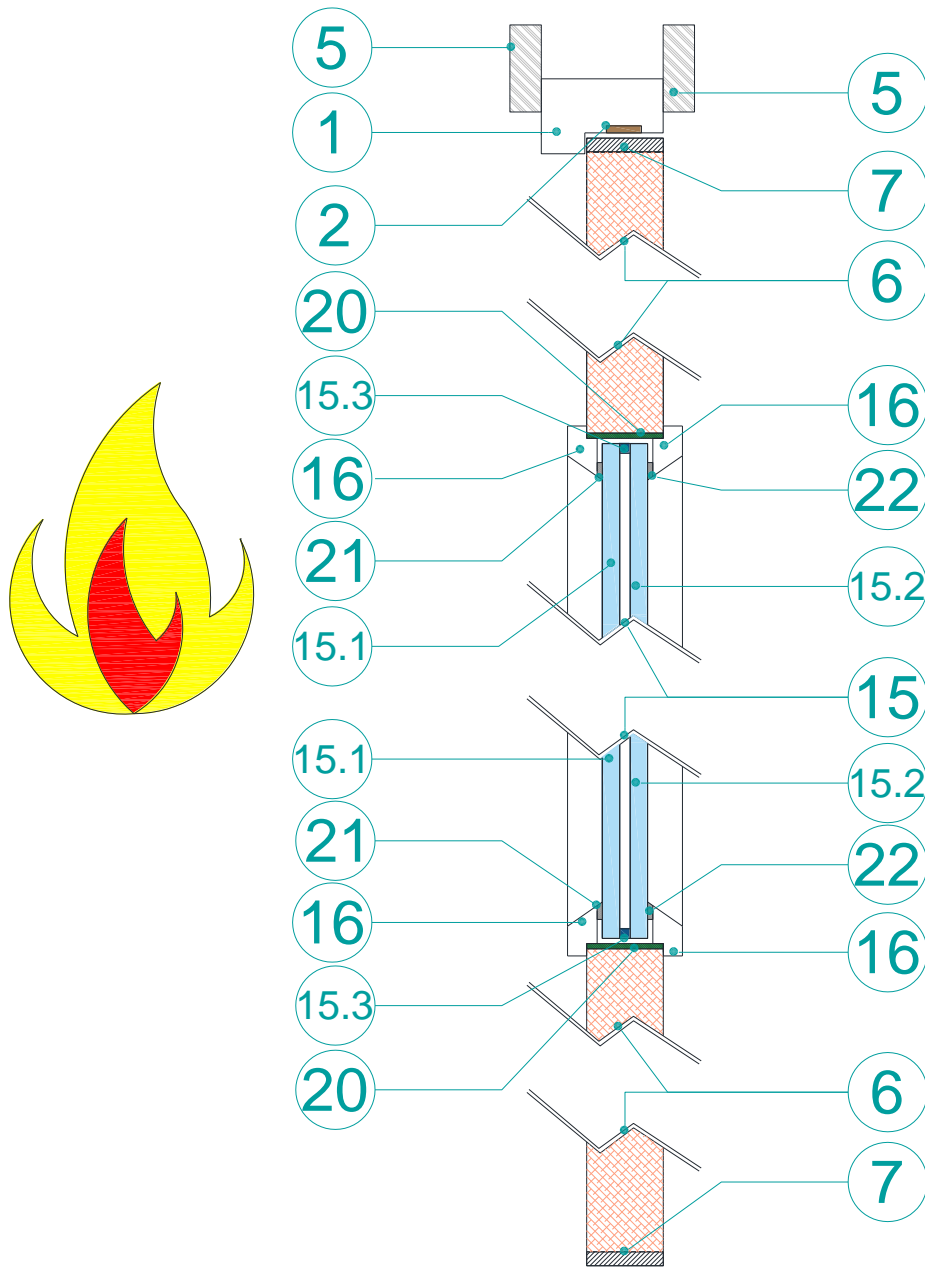
Figure 6 Vertical Sectional View - Doorset B

Representative Drawing

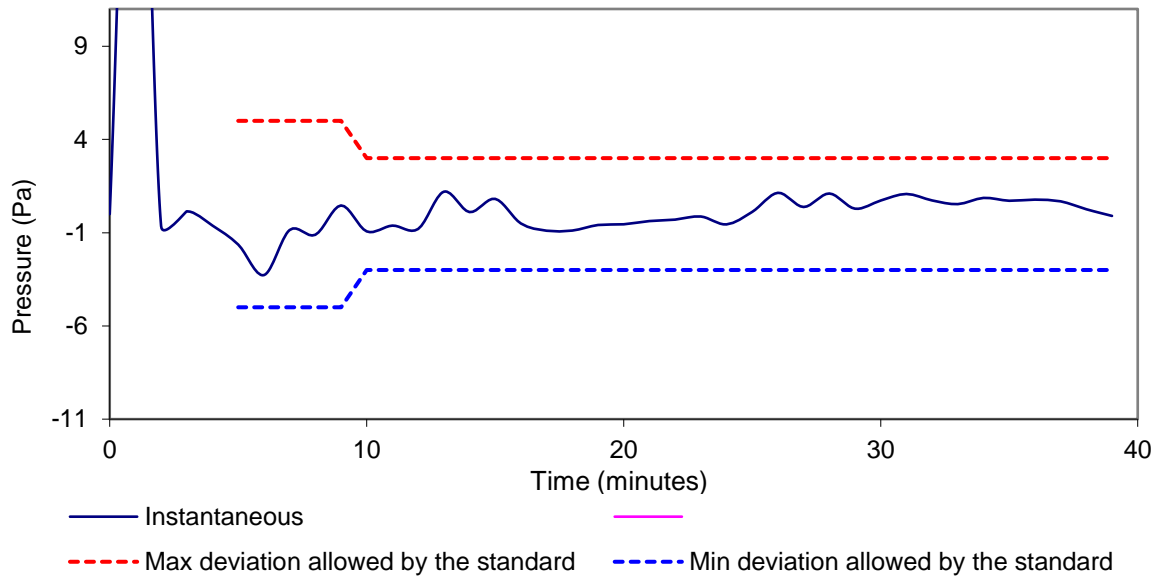
The furnace pressure was taken at approximately 500 mm above the sill of the test specimen.

Figure 12 Furnace pressure

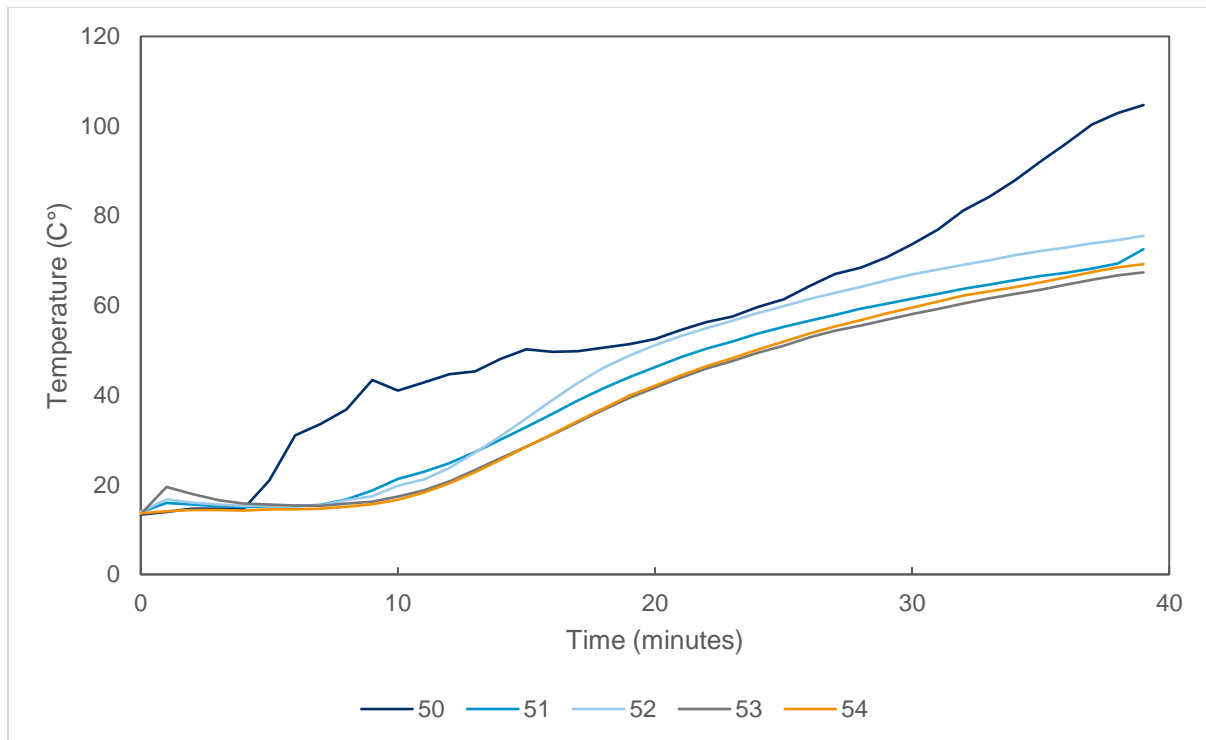
Figure 9 Individual and Mean Temperatures Recorded on the Unexposed Face of Doorset B

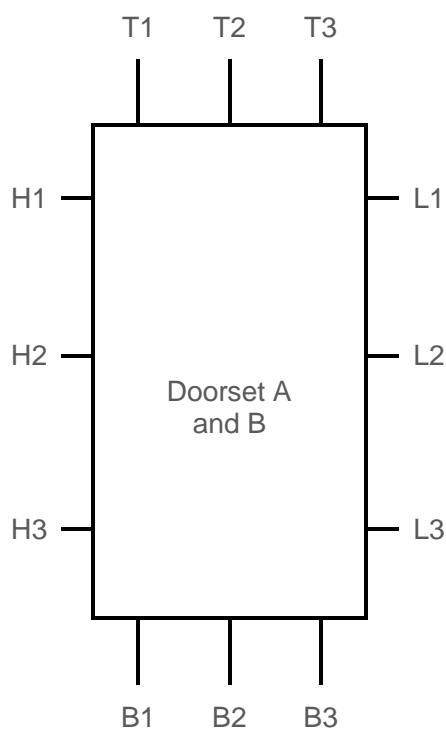
Figure 33 Clearance measurements, Doorset A and B (unexposed side shown)

Doorset B (mm)					
Hinge side	Primary	Leaf to stop	Leading edge	Primary	Leaf to stop
H1	3.6	N/A	L1	2.6	N/A
H2	3.3	N/A	L2	2.0	N/A
H3	3.2	N/A	L3	2.9	N/A
<b>Mean</b>	3.4		<b>Mean</b>	2.5	
<b>Max</b>	3.6		<b>Max</b>	2.9	
<b>Min</b>	3.2		<b>Min</b>	2.0	
<b>Max permitted</b>	5.5		<b>Max permitted</b>	4.7	
Top edge	Primary	Leaf to stop	Threshold	Primary	
T1	2.8	N/A	B1	4.5	
T2	2.3	N/A	B2	2.0	
T3	3.6	N/A	B3	2.0	
<b>Mean</b>	2.9		<b>Mean</b>	2.8	
<b>Max</b>	3.6		<b>Max</b>	4.5	
<b>Min</b>	2.3		<b>Min</b>	2.0	
<b>Max permitted</b>	5.3		<b>Max permitted</b>	5.7

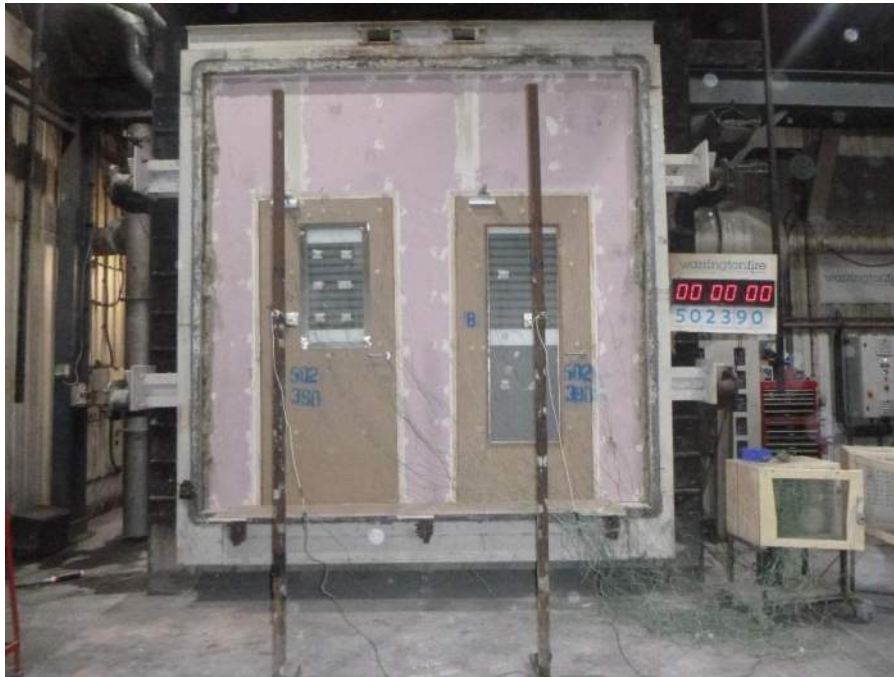
Figure 34 Unexposed face of the specimen before the start of the test

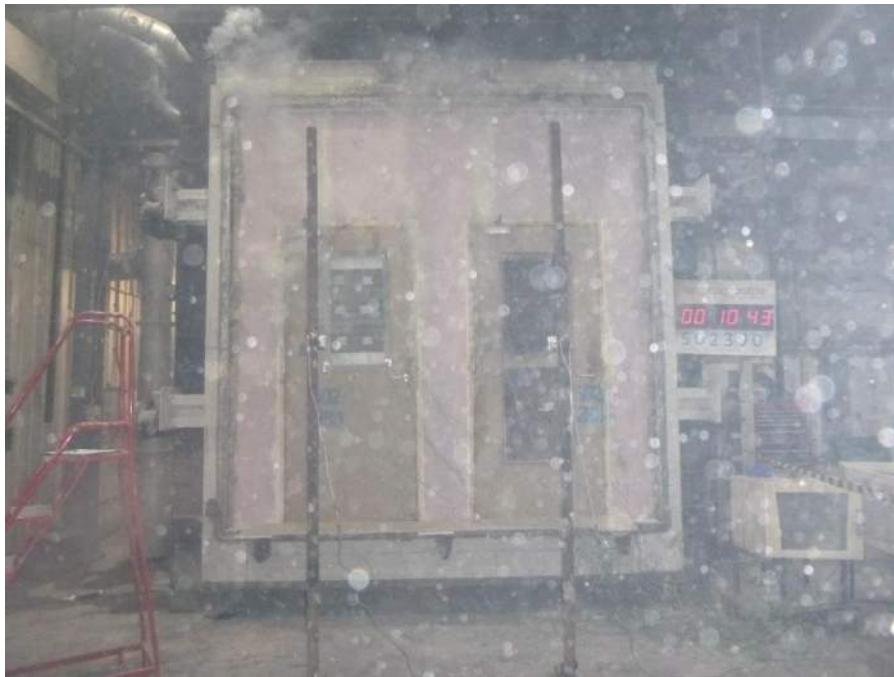
Figure 35 Unexposed face of the specimen after a test duration of 10 minutes

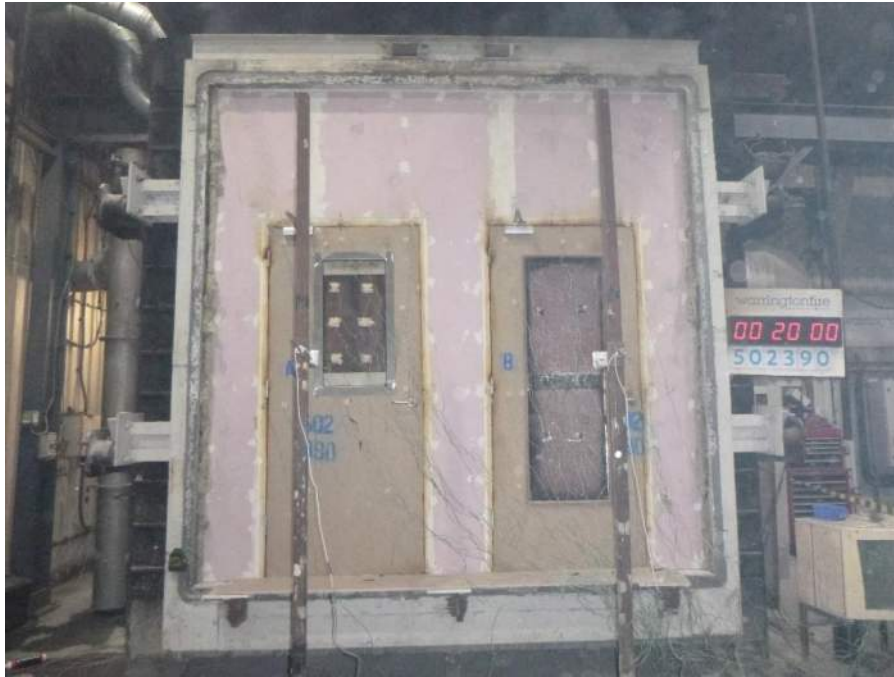
Figure 36 Unexposed face of the specimen after a test duration of 20 minutes

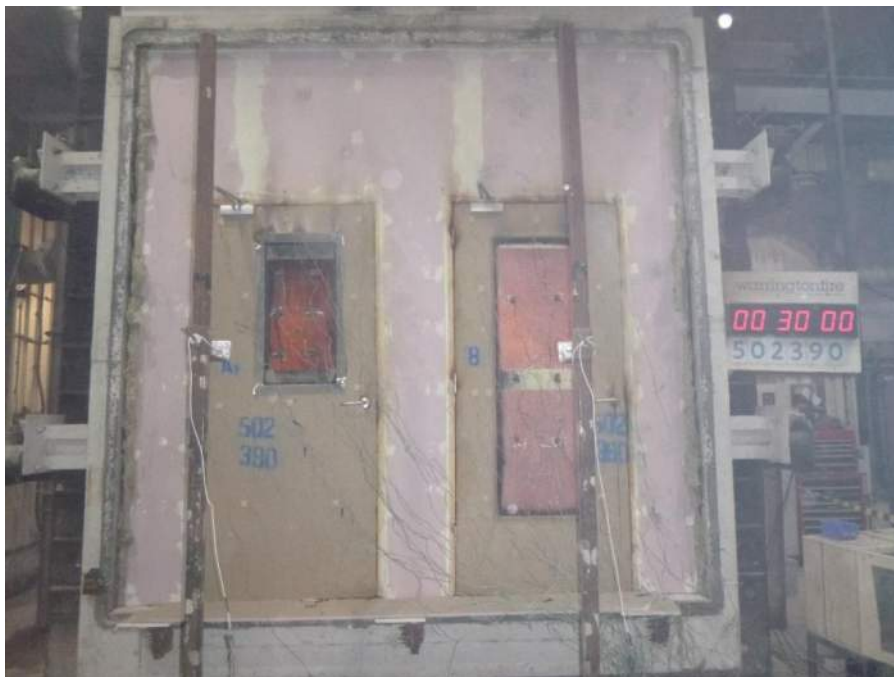
Figure 37 Unexposed face of the specimen after a test duration of 30 minutes

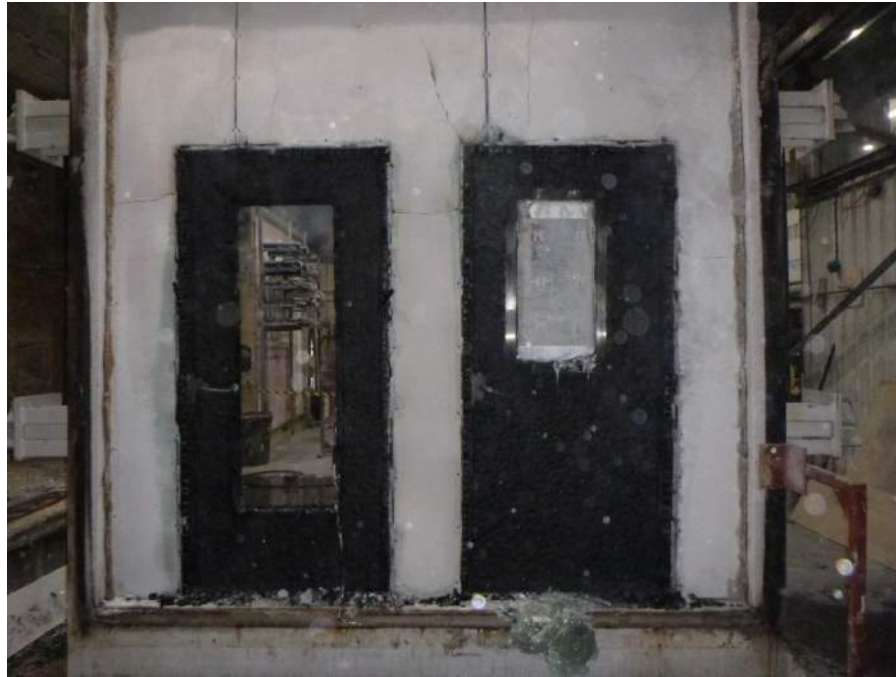
Figure 38 Exposed face of the specimen after the test
