Our Ref: Chilt/IF13037

**Re: Indicative Fire Resistance to the temperature and pressure conditions of
BS 476: Part 20/22: 1987 (and current FTSG Resolutions where applicable).
Test Chilt/IF13037**

The overall size of the leaf was 1250mm high x 1230mm wide x 54mm thick. and included two Vistamatic VS1 secure vision panels.

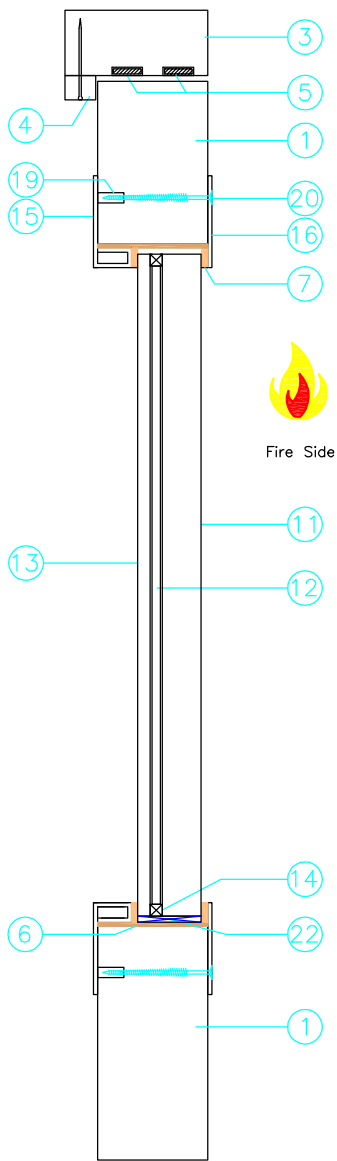
Section B-B

21.00	Glazing panel A, the middle glazing layer is cracking.
25.00	Glazing panel A, there is further cracking in the middle layer of the glazing.
27.00	Glazing panel A, a gap (approximately 1-2mm wide) has opened around the glazing bead.

28.10	Glazing panel A, there is an increase in the level of smoke issuing from the glazing perimeter.
29.00	Glazing panel B, the intumescent around the glazing is starting to react.

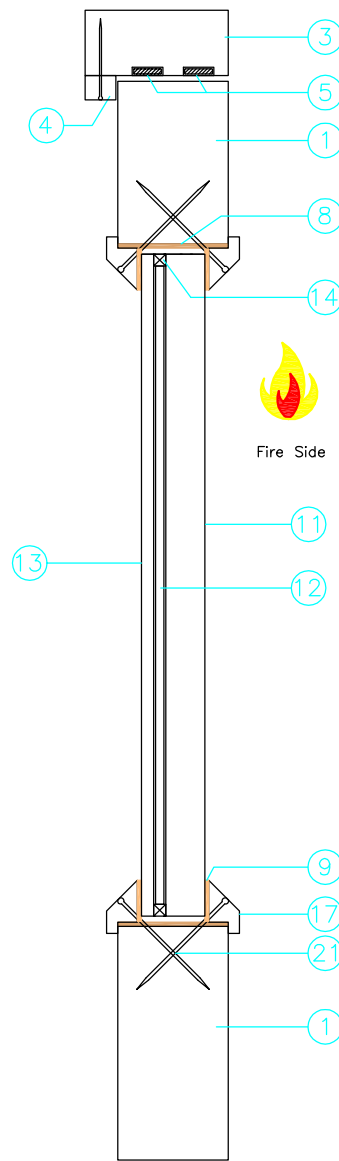
Section C-C

13.00	Glazing panel B, the exposed layer of glazing has shattered and the middle layer has cracked.
19.00	Glazing panel B, there are more cracks appearing in the middle layer of the glazing.

32.10	Glazing panel B, the unexposed glazing layer has cracked.
32.20	Glazing panel A, there is smoke issuing from around obscuring lever spindle of the glazing.
